## ADLINK Technical Document

<b>Abstract</b>	How to Fix “GPIB Utility.exe - Entry Point Not Found” Error		
<b>OS</b>	Windows		
<b>Keyword</b>	GPIB		
<b>Related Products</b>	USB-3488A, LPCI-3488A, LPCIe-3488A		
<b>Date</b>	2021-11-12	<b>No.</b>

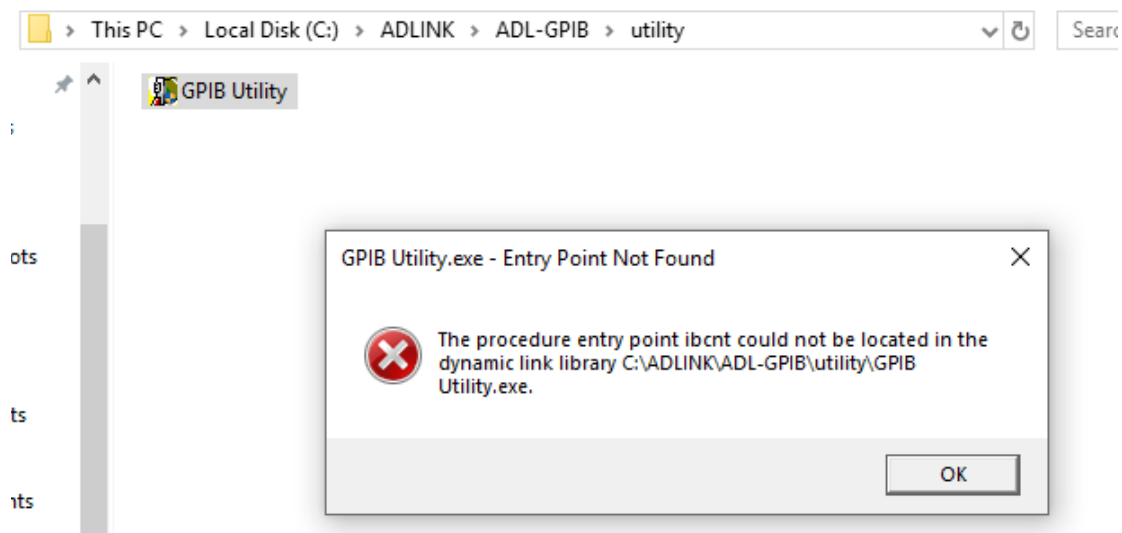
When launching the ADLINK GPIB Utility, the error message “GPIB Utility.exe - Entry Point Not Found” indicates an incorrect **GPIB-32.DLL**. This issue occurs when installing NI software, such as NI VISA, LabVIEW, and others, after installing the ADLINK GPIB software kits.

- Solution:

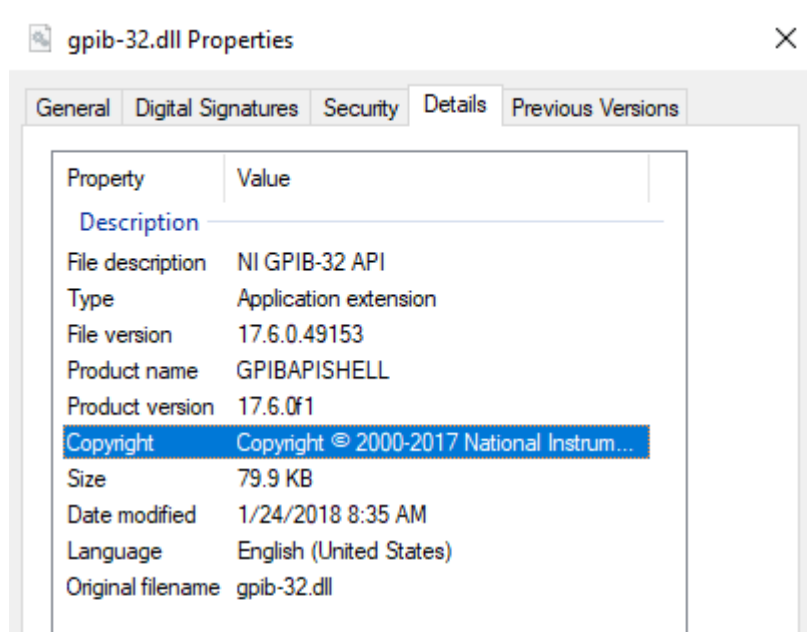
The file copyright should indicate ADLINK. If not, continue to the next step.

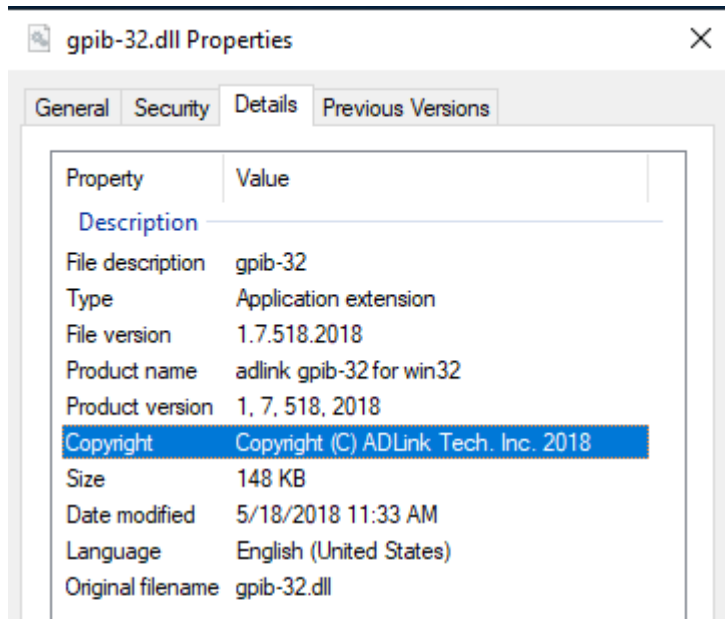
The file copyright should now show “ADLINK”.
